## Replacing the hub oil seal.

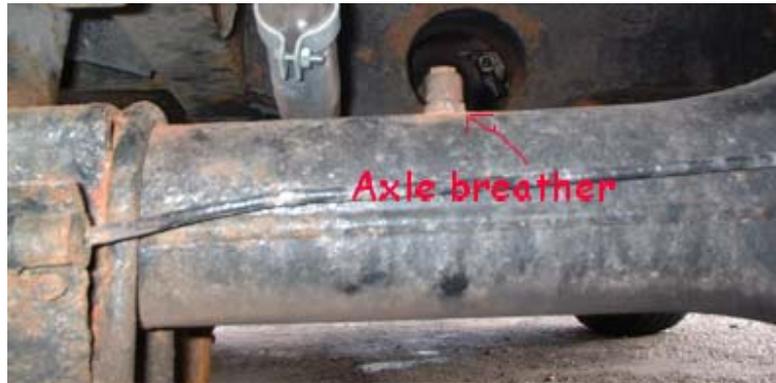
The most common reason for hub oil seal failure is a blocked axle breather, so check this first before you start.

Remove the brass bell-shaped fitting on the top of the axle, and give it a shake. There is a ball bearing in there, which will rattle if the breather is not completely blocked with dirt, if it does rattle, try blowing through the breather, as sometimes the outer part can be blocked with dirt, even if the ball bearing rattles inside. It is possible to clean them out with a bit of wire and some petrol, or WD40, though. It just needs a bit of patience!

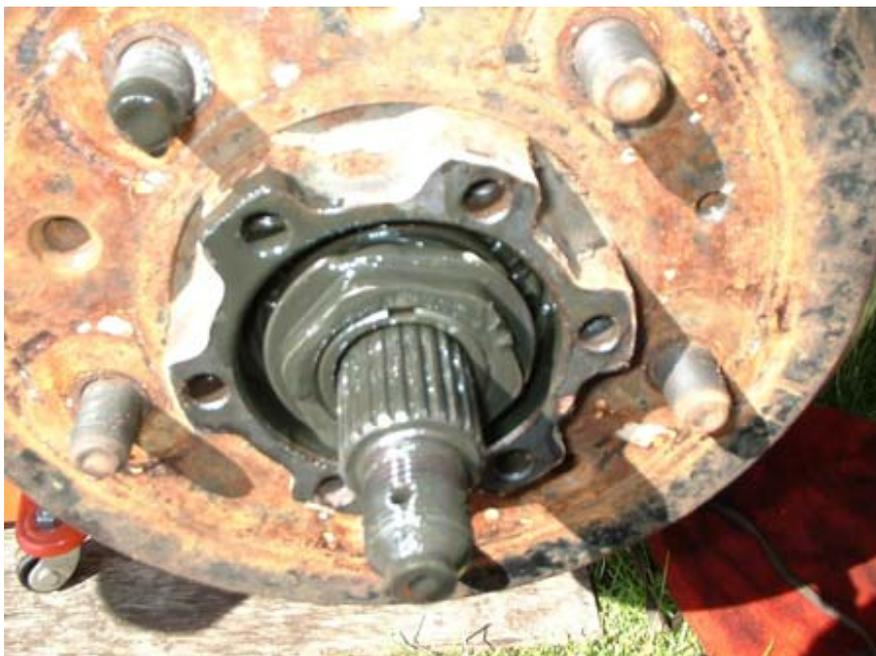
This next photo shows the drive flange removed, it is a front axle, so the half shaft is still in place.

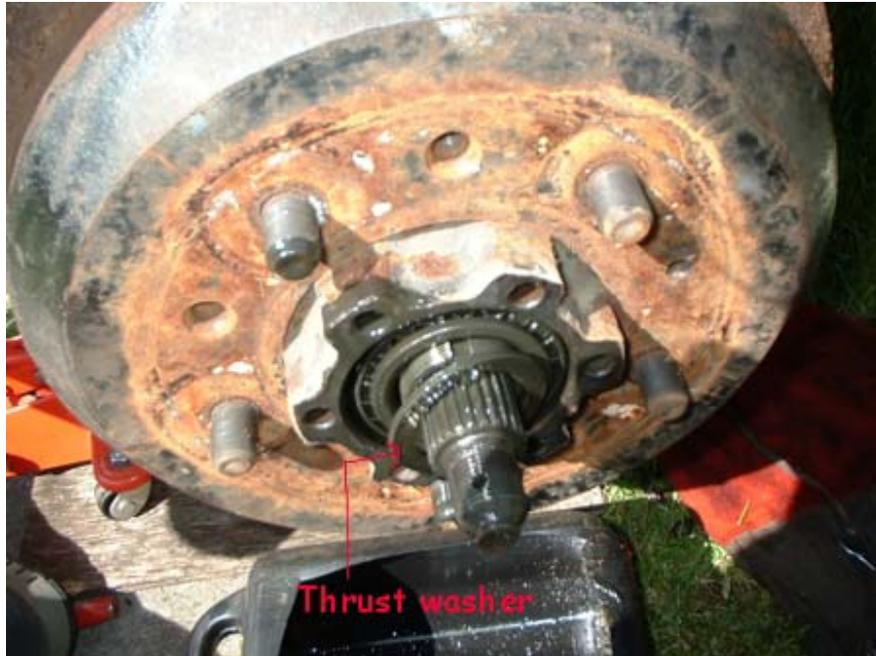
In the next photo you can see the nuts have been removed, and the thrust washer is visible.

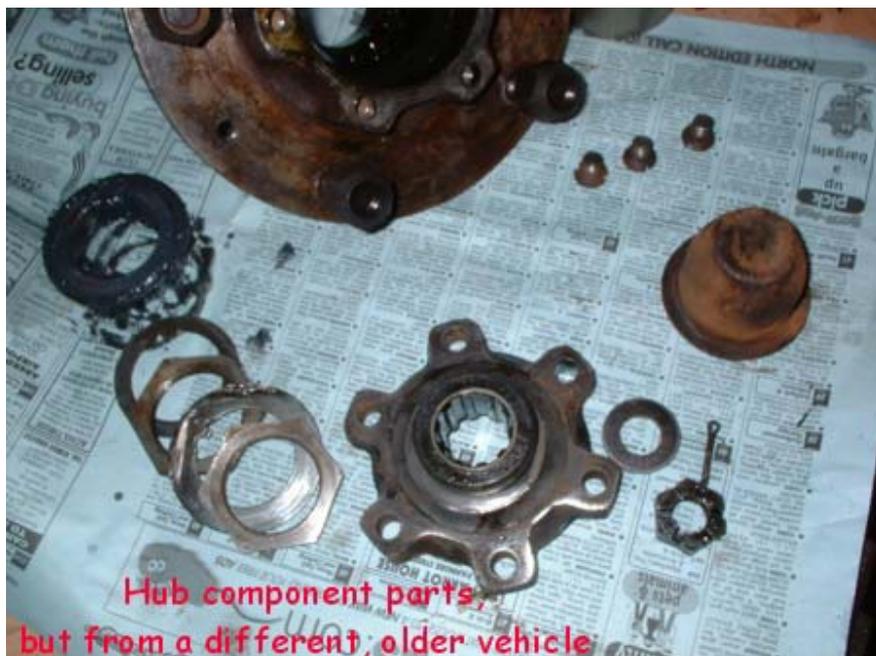
This next photo shows the front hub components as fitted to a SI. The only thing missing in the photo is the felt washer, but according to the parts book, there isn't one! The inner bearing is still in the hub at this stage.

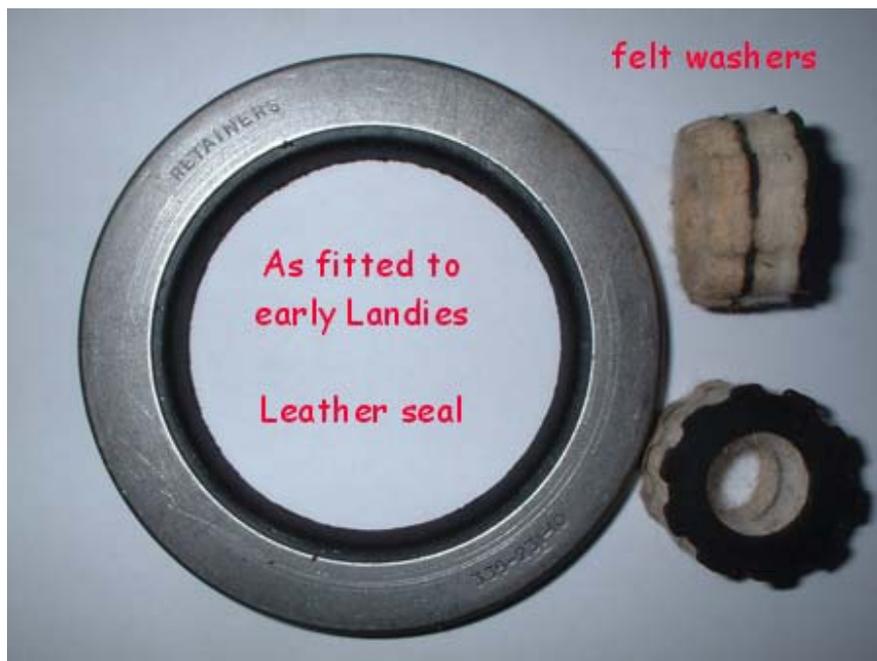
A quick look now at the new bits you will need. This next photo shows the original type of seal fitted to the hubs on early

Landies, the lips of the seal are made of leather! To the right of this seal are the felt washers you will need on all axles up to 1980. They are fitted with the neoprene side facing inwards.

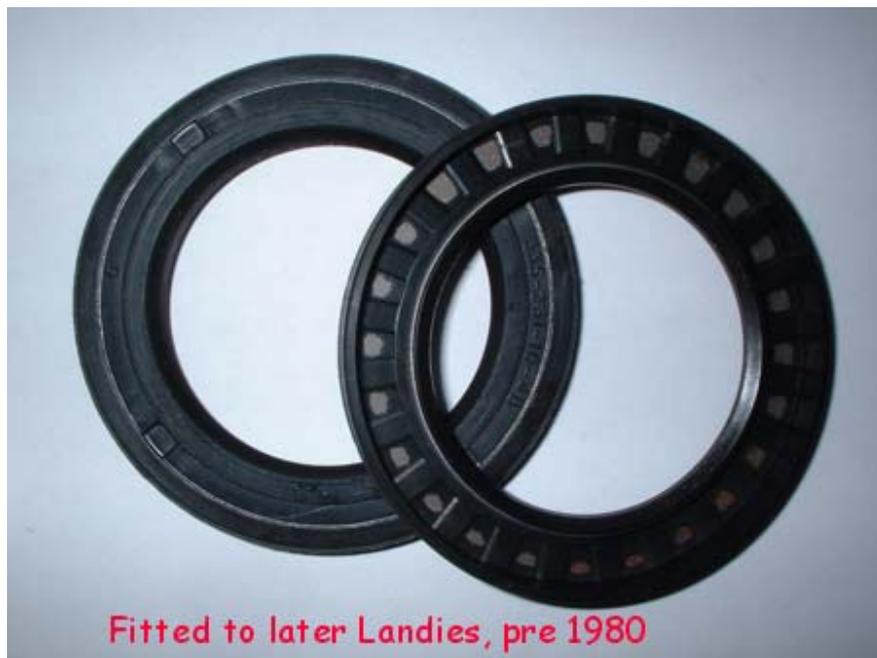
Now a quick look at the next type of seal, as fitted to Landies up to 1980, it is made of neoprene, and the top one on the photo is showing the inside of the seal.

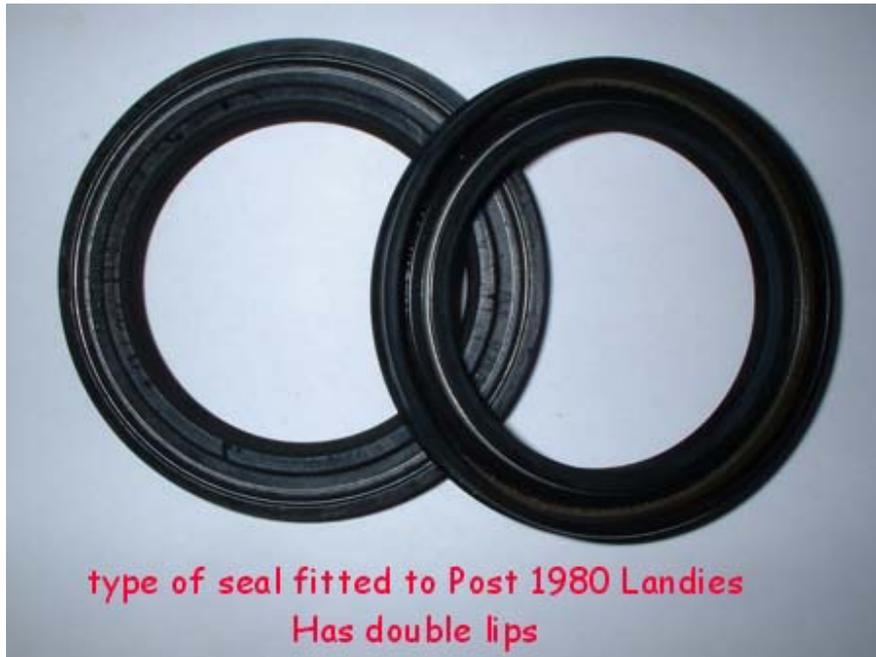
Now a look at the later type of seal, as fitted to axles made after 1980, again, the top seal is showing the inside (i.e. facing the inner bearing)

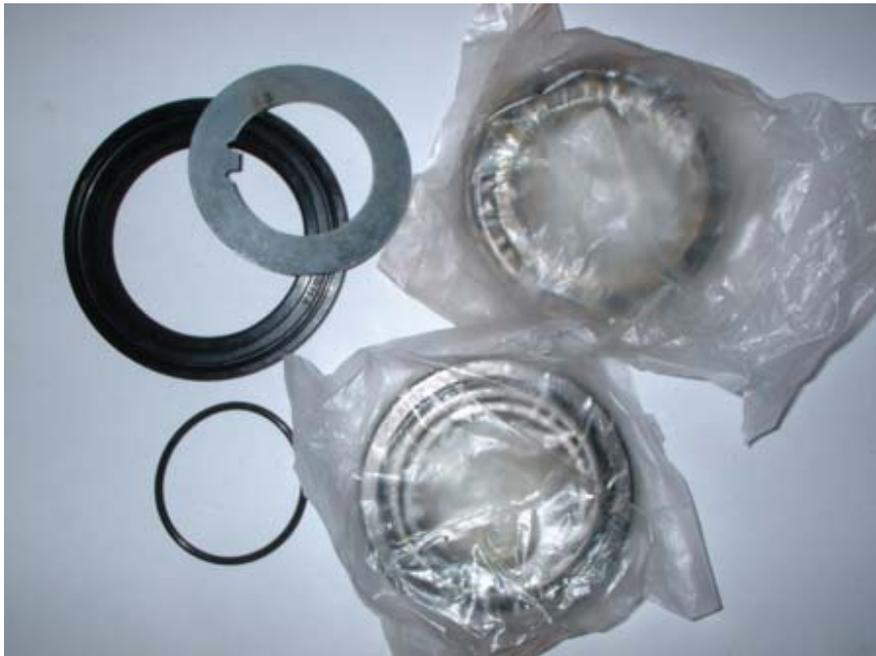
By far the easiest way to buy the parts you will need is to get a kit of bearings and seals, which at 2005 prices cost around £15 per hub, and include everything you need to replace the bearings in the hub, and the seals and gaskets. Here's a look at what comes in the kit for the later type of axle.....The paper drive flange to hub gasket is not visible in this photo.

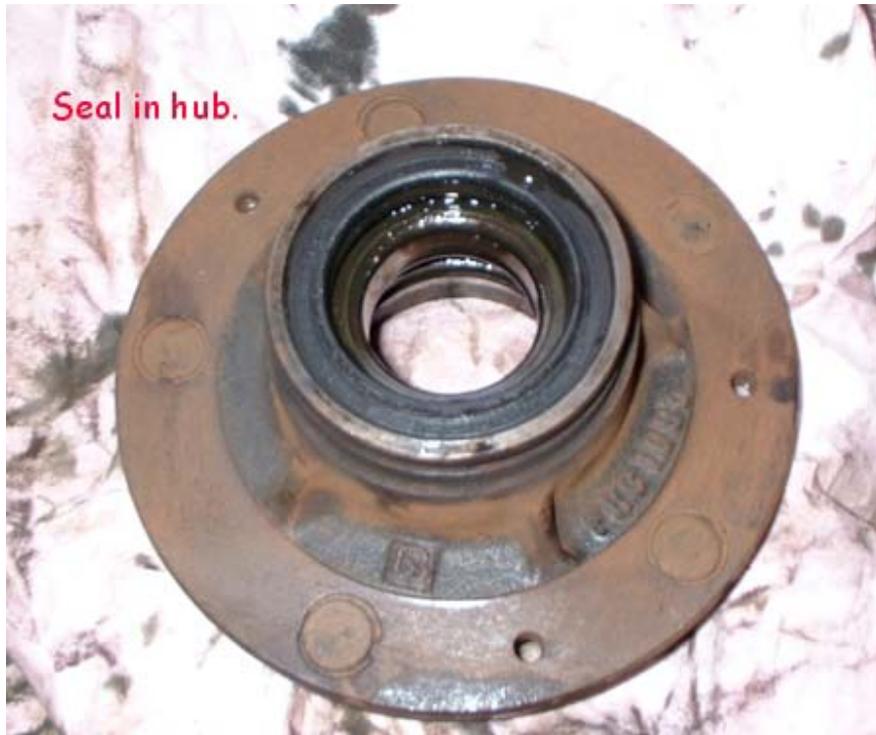
Insert the bearing into the race, and fit the hub oil seal. The lips of the seal should face the bearing. Now carefully and evenly press it home until it is flush with the edge of the hub.

You might use a big socket or similar for this, but it is important that the seal goes in evenly, and the lips are not damaged. The later type of seal, with two lips, as fitted to 1980 onwards axles should fit so that the outer of the lips is about 1mm below the hub casing. It has a lip on the outer edge of the seal too, and this should end up flush with the hub casing.

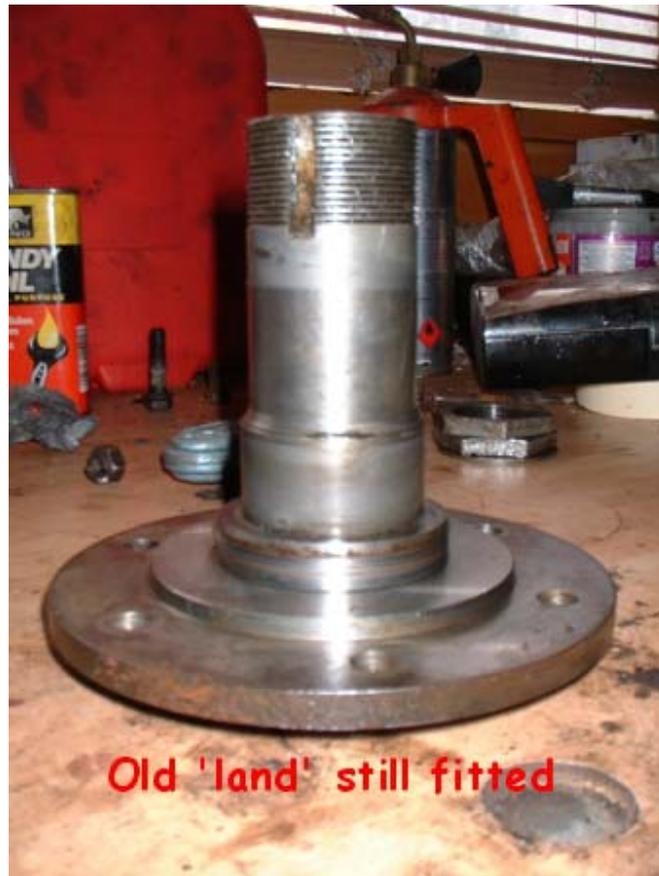
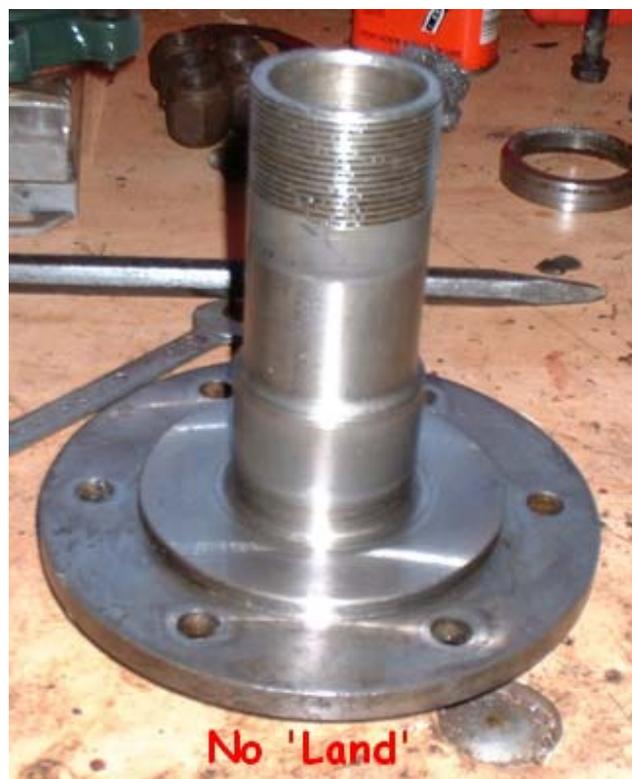
Before refitting the hub, check the stub axle for signs of wear. If your Landy has an early type of axle, (pre 1980), then the stub axle has a replaceable 'land' or distance piece.

The above photo's show a stub axle from an earlier axle, before and after removing the 'land', if the land is scored or worn as in the next photo, it will need to be removed and replaced with a new one.

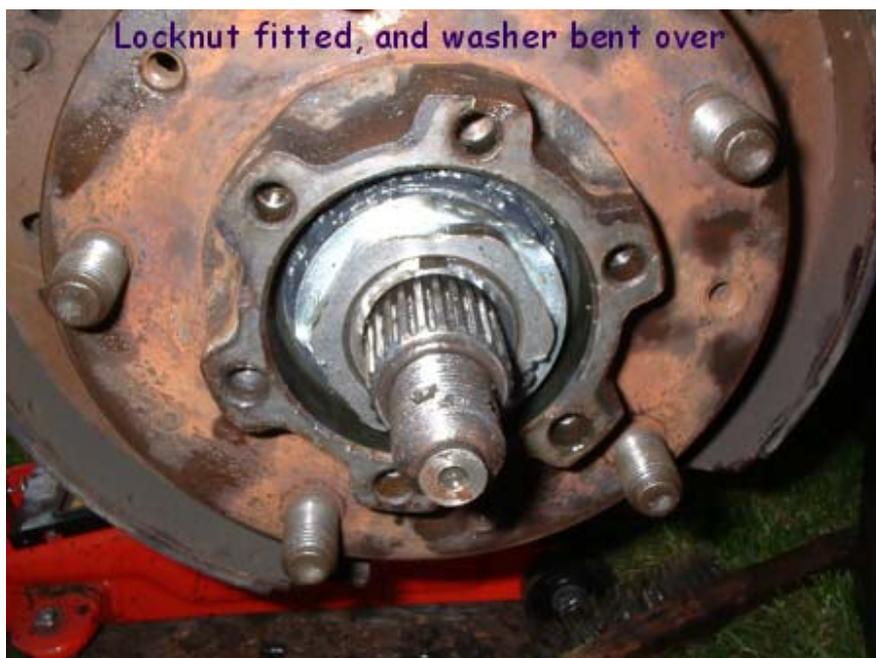
Once you are happy with the end-float, fit the lock-tab/washer, and the locking nut. Tighten the lock nut (check the end float again after doing this) and then bend the tabs over on the locking washer as in the next photo.
